INSPECTION REPORT

Garber & Woodward Architects, Cincinnati.
William Henry Harrison Memorial, 1924
Indiana limestone, other granite, limestone and marble types

LOCATION: Mt. Nebo, North Bend, Ohio.
PROJECT NO. 21183
ADDRESS: 41 Cliff Rd
North Bend, OH 45052

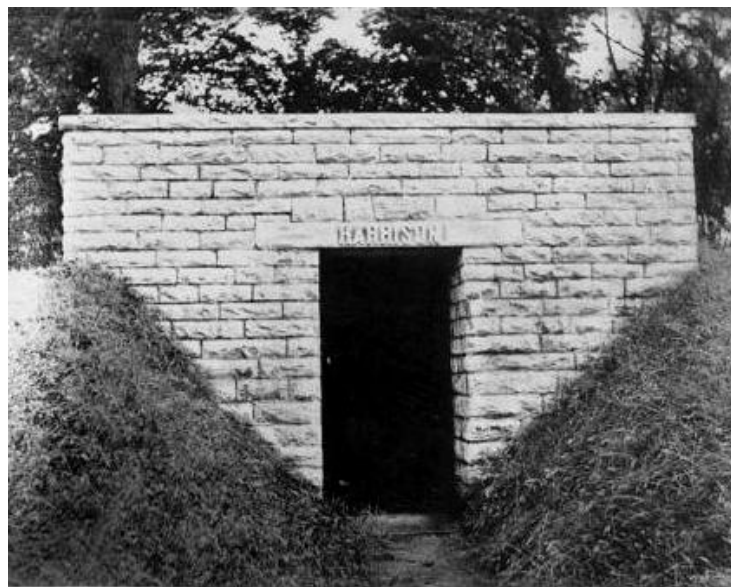
Fig.1. The W.H. Harrison Tomb after the improvements completed by Henry Harrison Memorial Committee 1922.

The tomb, originally a simple brick structure covered with sod, was built in 1841. Over the following years it had suffered a substantial deterioration, which was addressed by a commission (William Henry Harrison Memorial Committee) summoned to life by Horace Bonser in 1919. The tomb was then restored, and the currently present, rough-stone structure was built (Fig. 1). The official completion date is December 14th, 1922.
